BOARD OF INVESTIGATION FINAL REPORT

Double Contractor Employee Fatality Mishap

Mount Newall, Antarctica

Date of Event – December 12, 2018

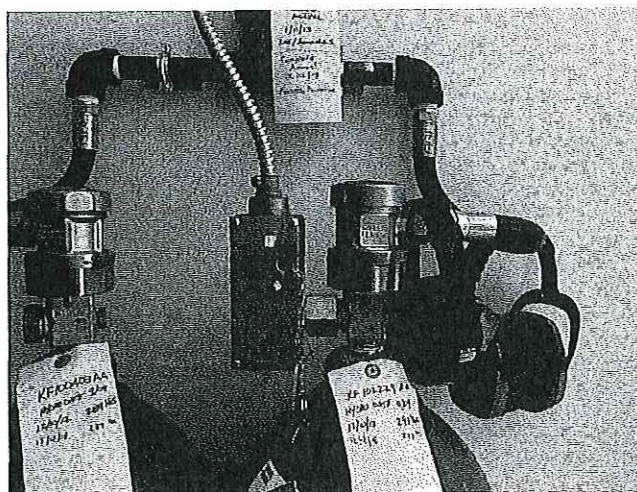
MV's reported having completed the prescribed maintenance procedures for the fire suppression system (CO₂). The amount of time MV's spent performing each of the 33 tasks is unknown. (Note: When the system was visited by investigators, it was discovered that the pin was out of the electronic control head on the CO₂ bottle as seen in Figure 1)

Figure 1: Bull Pass Fire Suppression System (CO₂) with locking pin removed from manual release lever

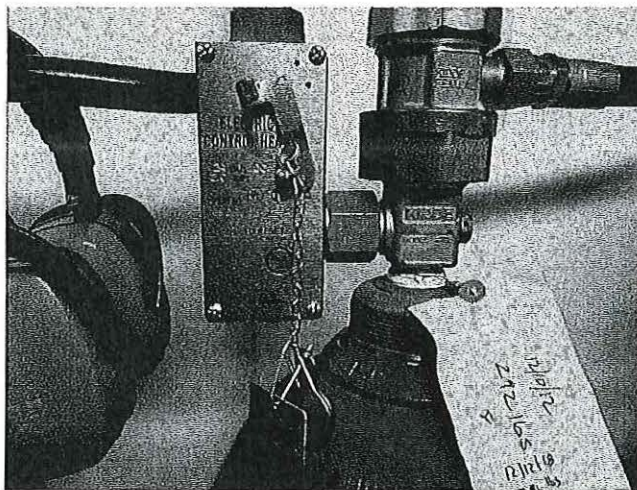
Figure 2: CO₂ Fire Suppression System (center bottle) at Mount Newall with locking pin out, manual release turned left, and system activation indicator in the "released" position.

7. *Manually triggered release of CO₂ system.* The forensic analysis of the electric control head determined that it was unlikely the manual release switch was activated by a mechanism other than human means.

Recommendation 7: Validating employment, training, and hazard analysis processes are in place to mitigate the risks associated with fire suppression system (CO₂) maintenance tasks.

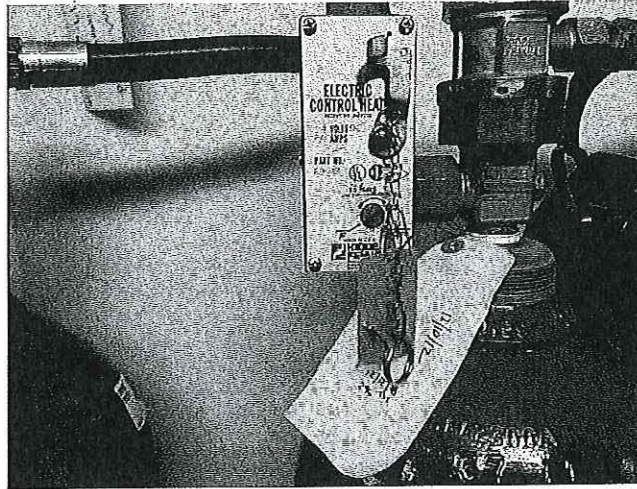
Figure 3: CO₂ Fire Suppression System (right bottle) at Mount Newall with locking pin out, manual release straight up, and system activation indicator in the "set" position.
