UIL HOLDINGS CORPORATION

*Connecticut Legislature
Tropical Storm Irene Hearing
September 19, 2011*

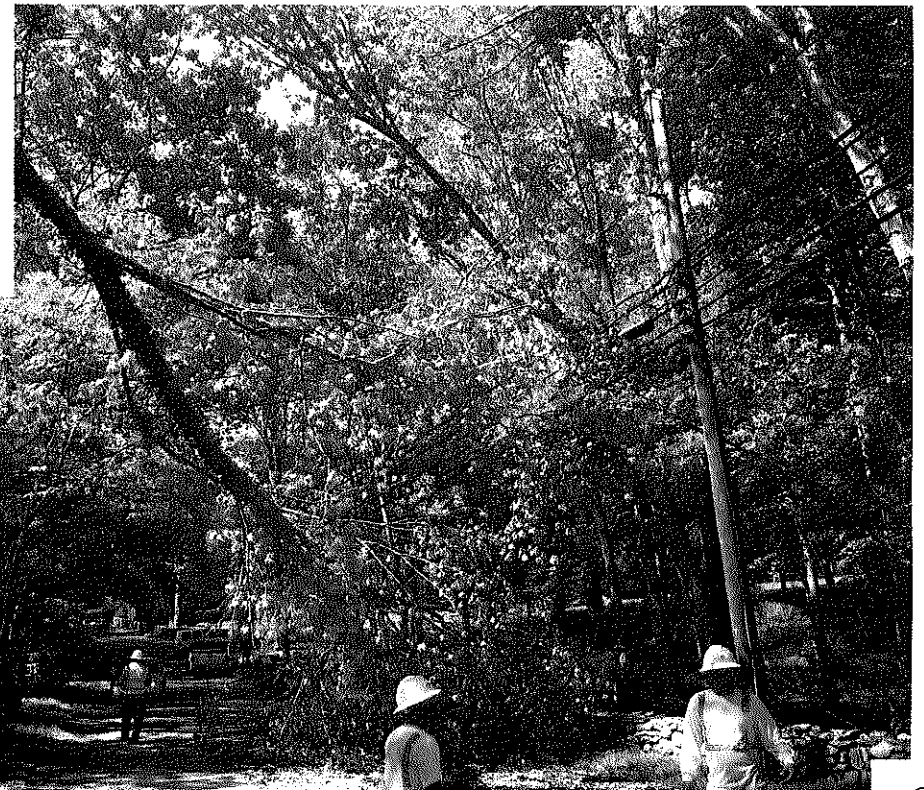
- Catamount Rd., Fairfield, CT
- In addition to the damage ...
- Note how completely the tree canopy blankets the area.

- As well as we did, restoration could be shorter if damage can be reduced ...
 - *More aggressive tree management*
- We didn't always meet the information-expectations of our customers and government leaders ...
 - *Need to further develop and add methods & processes for conveying useful information.*

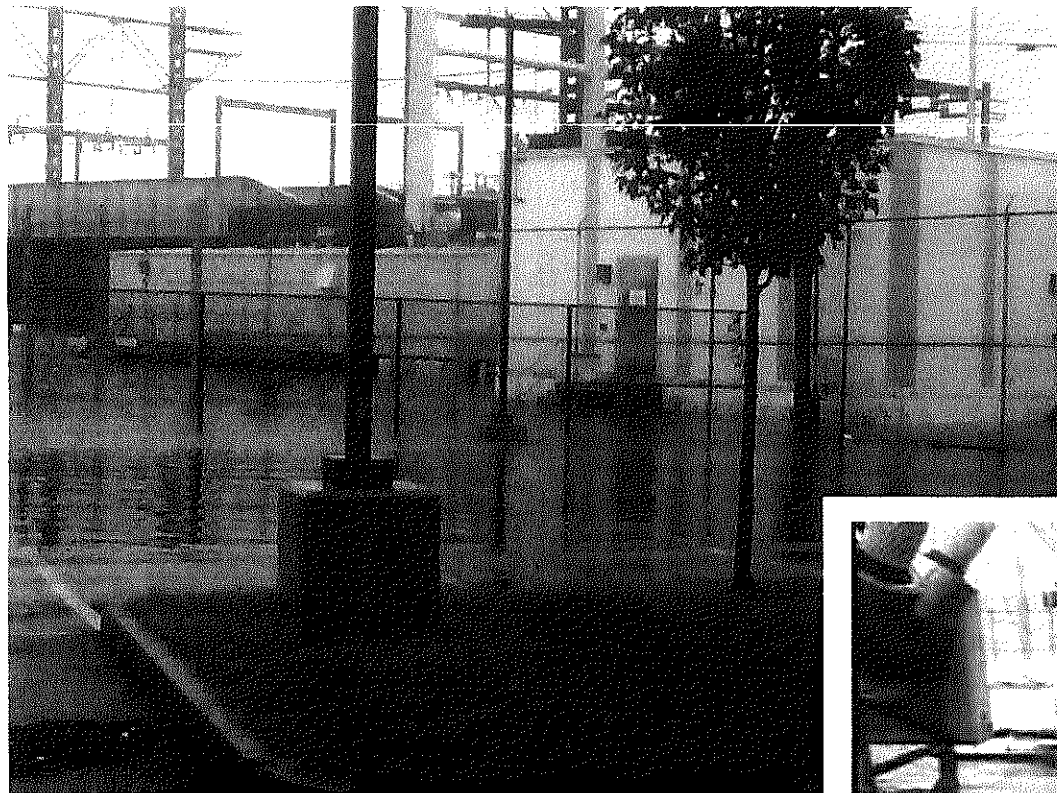
- Peak of storm roughly coincidental with high tide.
- Extensive flooding at two substation properties
- One of two flooded substations taken off line as a precautionary measure.
- Put back in service quickly
