Increased Deflection Agricultural Radial Tires Following the Tire and Rim Association IF, VF, and IF/CFO Load and Inflation Standards

Bradley J. Harris
Firestone Agricultural Solutions
Des Moines, Iowa

**For presentation at the
2017 Agricultural Equipment Technology Conference
Louisville, Kentucky, USA
13-15 February 2017**

ASABE Publication Number 913C0117
ASABE Distinguished Lecture Series,
Tractor Design No. 39

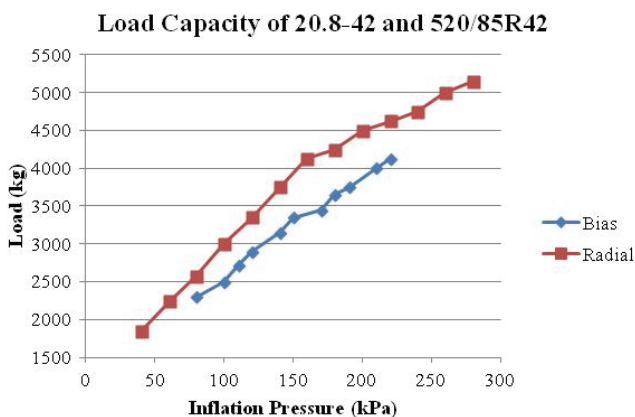
Figure 2. Graphical view of load table for 20.8-42 and 520/85R42 tires (from Tire and Rim Association, Inc., 2016 Year Book).

A radial tire is designed to deflect more than a bias tire. The higher deflection allows the radial tire to carry more load at the same inflation pressure as a bias tire. To illustrate this, compare a 20.8-42 bias tire with a 520/85R42 (20.8R42) radial. In the Tire and Rim Association standard, these tires are the same size, just different constructions. As a radial, the 520/85R42 will carry 12% to 19% more load at the same inflation pressure than the bias tire. Table 1 compares the per-tire load carrying capacity of a bias 20.8-42 to the radial 520/85R42 (20.8R42) at common inflation pressures. Figure 2 compares the load tables at all the base inflation pressures.

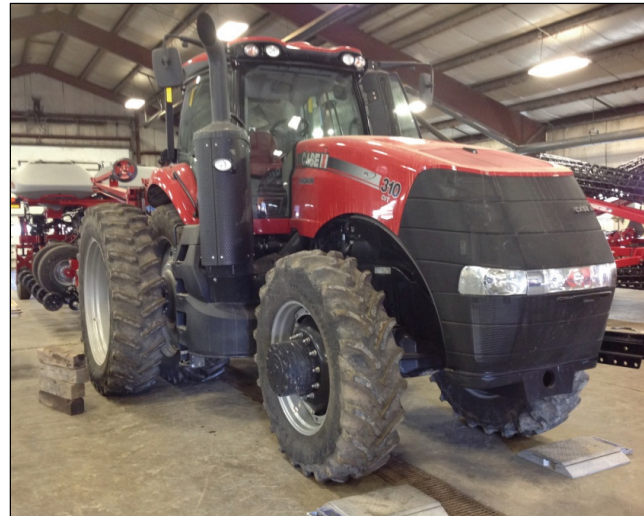
Figure 3. Case IH Magnum 310 tractor with 16 row Case IH 1255 planter being weighed in spring 2016.

The 12% to 19% increase in load capacity doesn't seem like much, but when these two tires are placed on a mechanical front wheel drive tractor with a PTO output of 198 kW and pulling a 16-row front fold corn planter, the inflation pressure increases could be considered significant. In the spring of 2016, a Case IH Magnum 310 tractor with a 16-row Case IH 1255 corn planter was weighed by Bridgestone Americas' Tire Operation. The tractor rear axle weight with the planter in transport position without any seed or fertilizer was 12,610 kg (Figure 3). Using a single tire configuration on the rear axle of the tractor, each rear tire would need to carry 6,305 kg. The load and inflation table shows neither the 20.8-42 nor the 520/85R42 in a single tire configuration would have enough load capacity

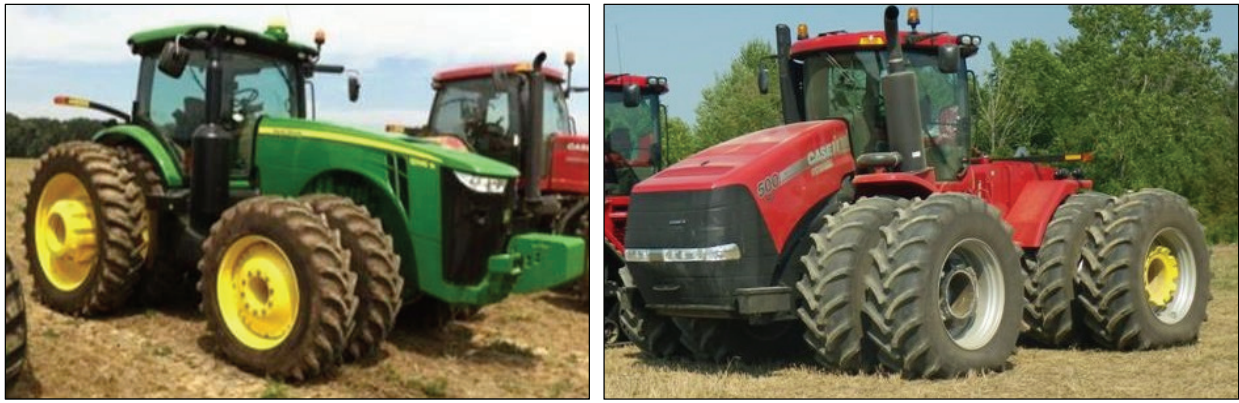
Figure 8. Test tractors.

Testing was completed with the sensor buried in sand and allowed for 3 or 4 inches of sand to cover the top of the sensor. The tractors were driven across the sensor first in one direction and then in the reverse direction. A pressure recording was created during the length of the run. The recording was created for both the left side of the tractor and then the right side of the tractor. After each run the sand over the sensor was raked up and returned to the original uncompacted state. Testing was completed with $\approx 0\%$ wheel slip, as no drawbar load was applied to the tractor. The test tractors were a John Deere 8335R MFWD with dual 420/85R34 tires on the front axle and dual 480/80R50 tires on the rear axle and a Case IH Steiger 500 4WD with dual 710/70R42 tires on the front and rear axles (Figure 8).

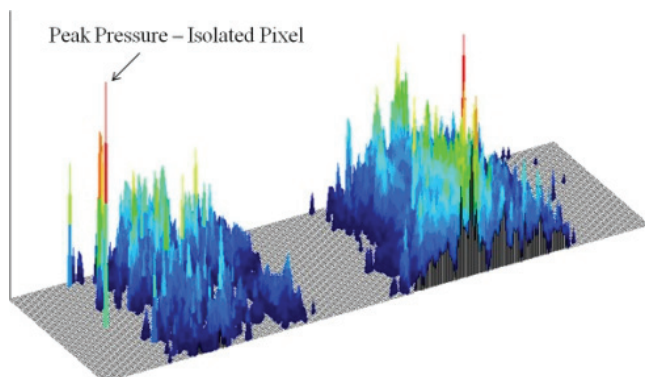
Figure 11. Peak pressure example.

The peak pressure sensed by any pixel in the sensor was recorded. Following testing, the data were analyzed, and it was determined that the peak value is related to pebbles, stones, or other debris on the sensor (Figure 11). The peak pressure locations are isolated points on the sensor that do not represent true peaks as caused by a tire. It was determined that the peak pressure should not be used to make judgments about soil compaction.

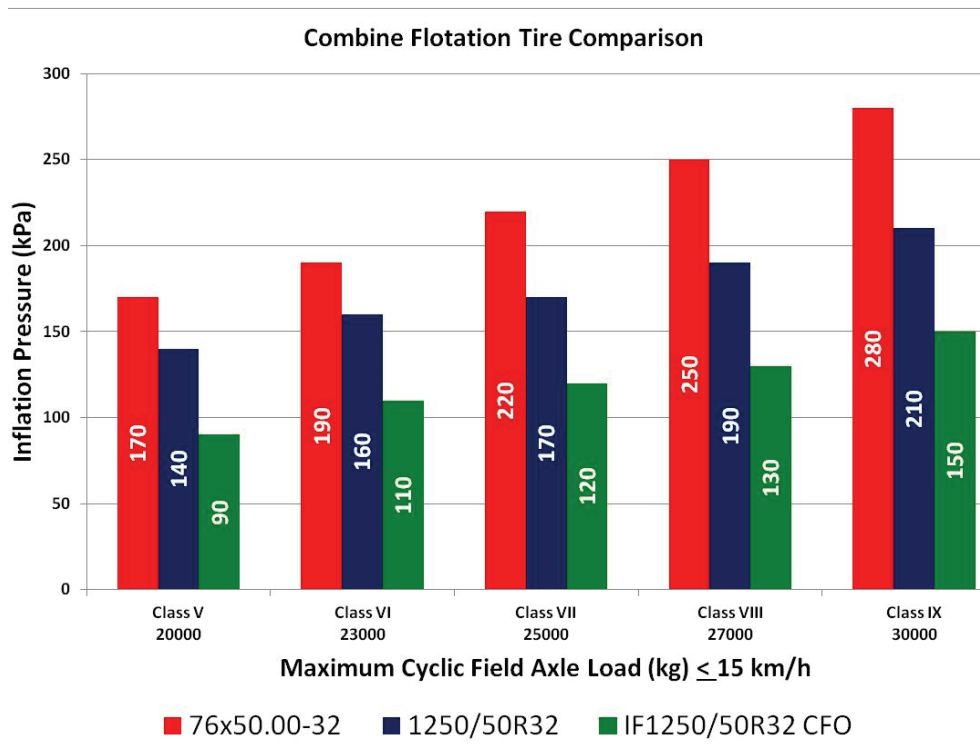
Figure 12. Inflation pressure needed to carry harvester drive axle loads.

The next progression of IF/VF technology will be in the harvesting sector. Manufacturers are developing Class IX combines, and standard radial tires are requiring up to 360 kPa. To address this need the tire industry has developed the IF/CFO (Cyclic Field Operation) standard. This standard allows a tire marked IF/CFO to carry 55% extra load when used at speeds less than 15 km/h on equipment like combines and grain carts that are loaded and then carry weight for distances less than one mile. Figure 12 is an illustration on the inflation pressure required to carry the axle load typically experienced on various classes of combines. The x-axis is the typical axle load (kg) of various classes of combines, and the y-axis is the inflation pressure to carry the axle load. There are three tires listed: a 76x50.00-32 Bias flotation tire, a standard 1250/50R32 Radial, and an IF 1250/50R32 CFO Radial. With the new IF/CFO standard, the IF1250/50R32 CFO will carry the axle load of a Class IX combine at the inflation pressure of the 76x50.00-32 on a Class V combine. These IF/CFO tires are also approved for use on grain carts.
